# IMPLANT LEVEL

Highly Resilient Disaster Prevention Levee

Levee Upgrading Work in Japan

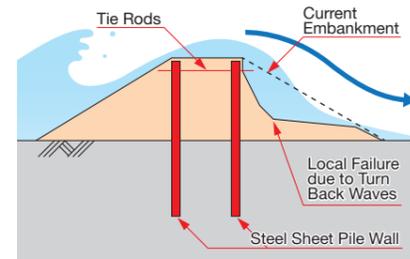
**Flood, Storm Surge and Tsunami Protection**  
Functions of the levee can be maintained by increasing its stability.

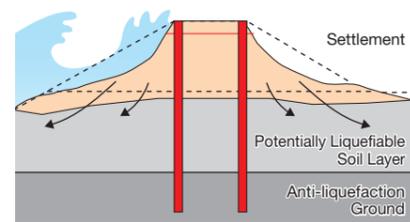
**Liquefaction Protection**  
Functions of the levee can be maintained by the ground enclosure effect.

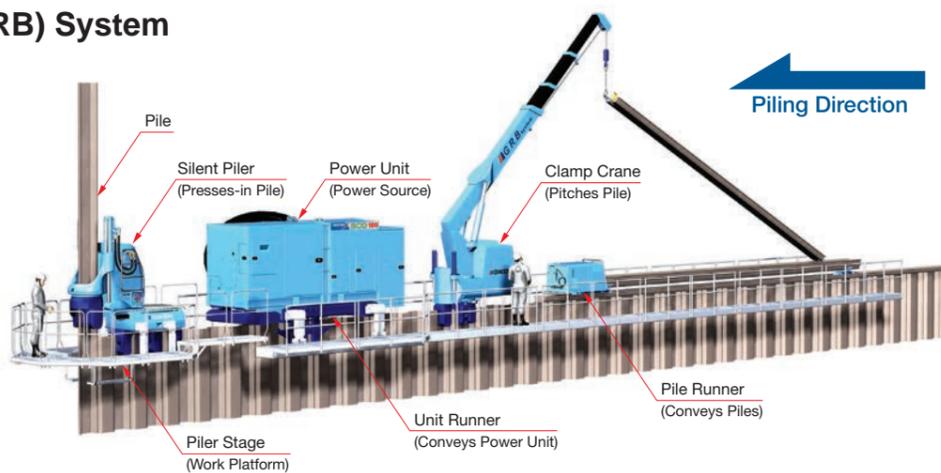
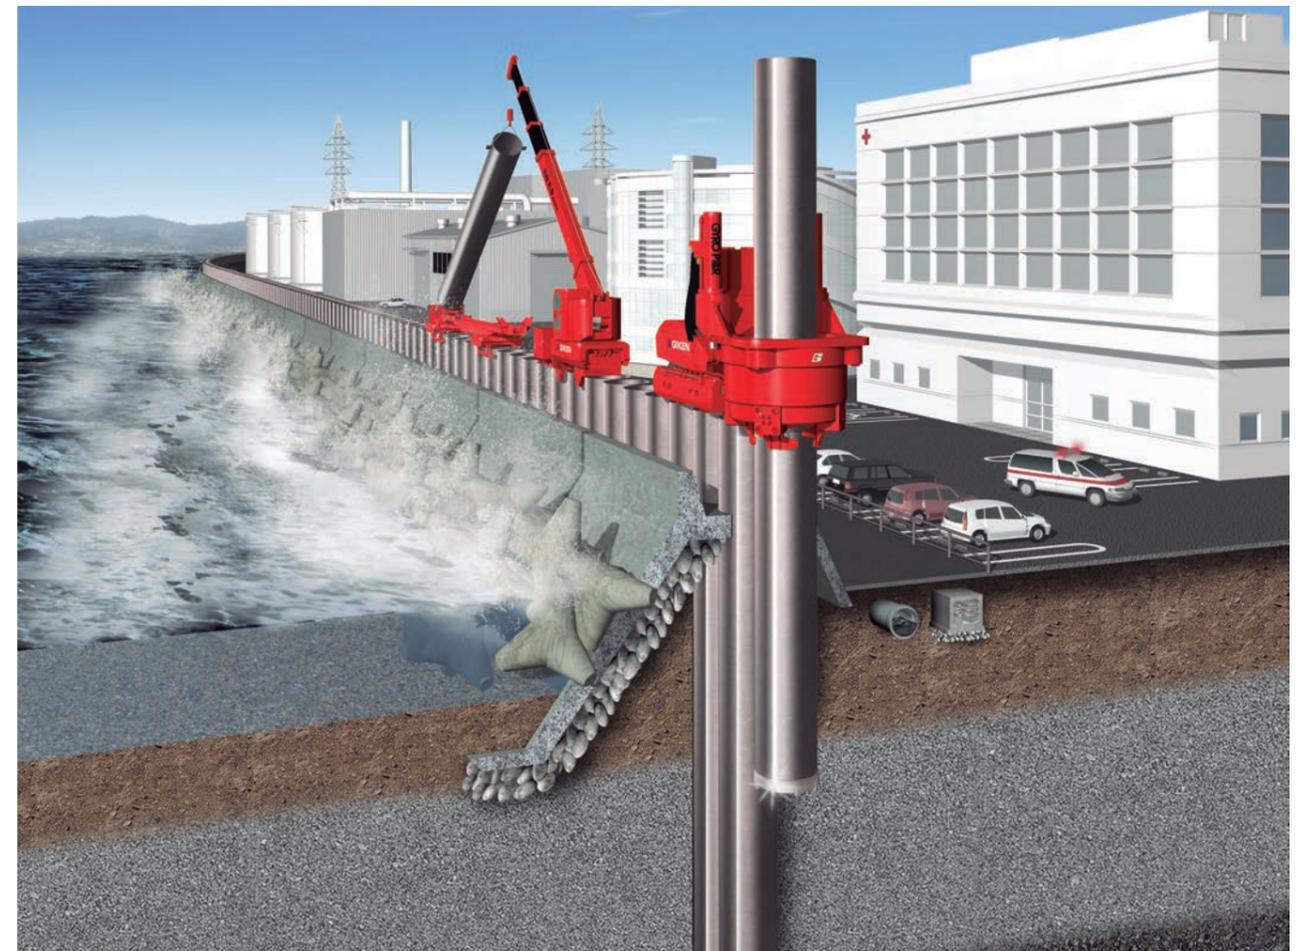
The press-in machine utilizes reaction force from previously installed piles and performs piling work on top of the piles. With further development based on the principle of "reaction based mechanism", "the GRB System" was developed as a press-in system which performs all piling procedures such as; pile transportation, pile pitching and press-in work, on top of installed piles.

The GRB System consists of a Silent Piler in the front, a Power Unit as a power source, a Clamp Crane to pitch piles and a Pile Runner to convey piles from storage site.

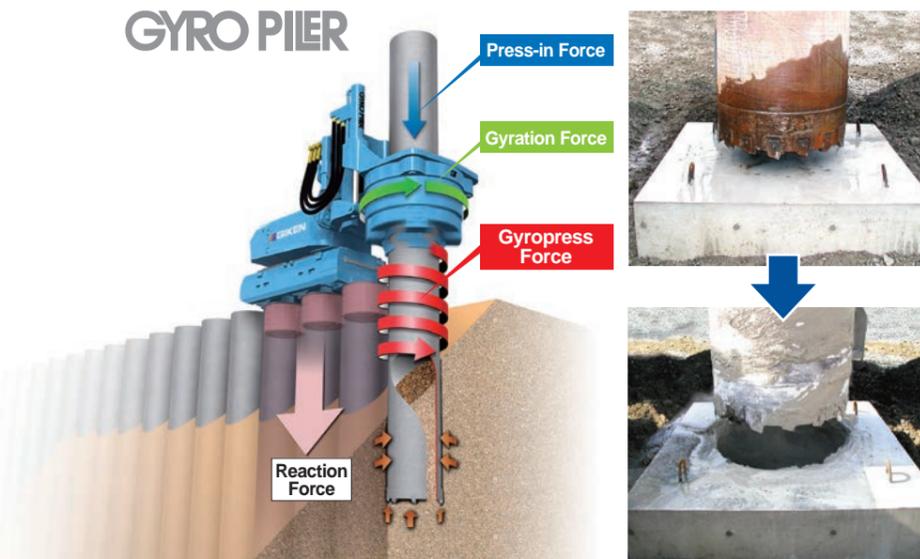
## GYRO PIER

Gyropress Method installs tubular piles with cutting bits attached on pile toe by rotary jack-in system, and travels on top of piles which are completely installed (completed piles).

Gyropress Method allows the installation of tubular piles without prior removal of existing structures and/or obstacles.

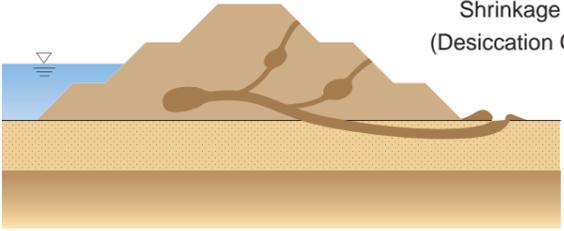
Animal Burrowing Shrinkage Cracks (Desiccation Cracks)	Water entering the embankment through surface cracks or animal burrows could reduce the soil strength of the levee. This may compromise the stability of the embankment and, in turn, reduce the ability of the levee to perform as designed during high water events.	<b>Negligible</b>	<b>Moderate - High</b>
<b>Internal Erosion</b>

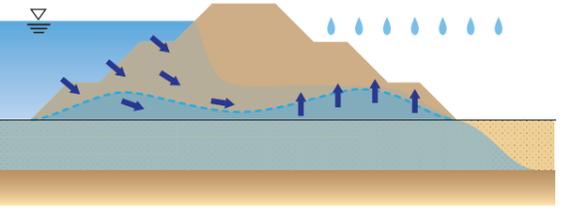
Seepage Suffusion	The hydrostatic pressure against a levee slope increases significantly and can force water into the levee embankment and its foundation. This seepage will generally follow paths of least resistance. Depending on the geotechnical properties of the soil, internal erosion may then happen.	<b>Negligible</b>	<b>Moderate - High</b>
<b>Settlement</b>

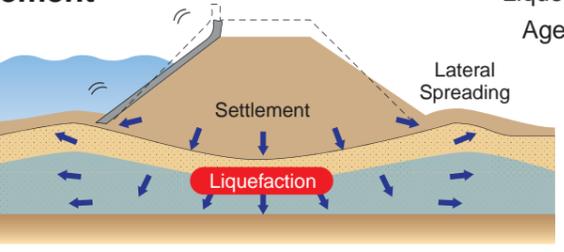
Liquefaction Age Effect Settlement Lateral Spreading	Large seismic accelerations cause settlement and loss of effective shear strength in water-saturated, unconsolidated sediment, leading to loss of bearing pressures and lateral spreading of levee.	<b>Negligible - Low</b>	<b>High</b>

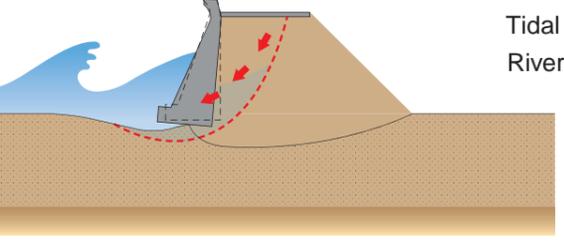
Flood Tidal Action River Flows	Levees can breach before overflow/ overtopping if there are structural issues with the levee making it unstable under a hydraulic load.	<b>Negligible</b>	<b>Moderate - High</b>
<b>Collapse (Widespread Devastation)</b>

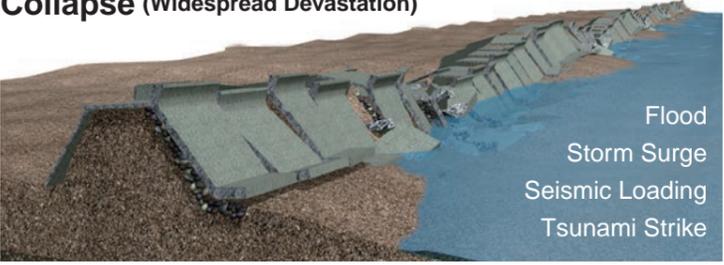
Flood Storm Surge Seismic Loading Tsunami Strike	Large external cyclic loading due to these catastrophic events may lead to large parts of the levee collapsing or significant deformations. The levee failure occurs when the weakness of the levee reaches an unsustainable ultimate state.	<b>Negligible - Low</b>	<b>High</b>

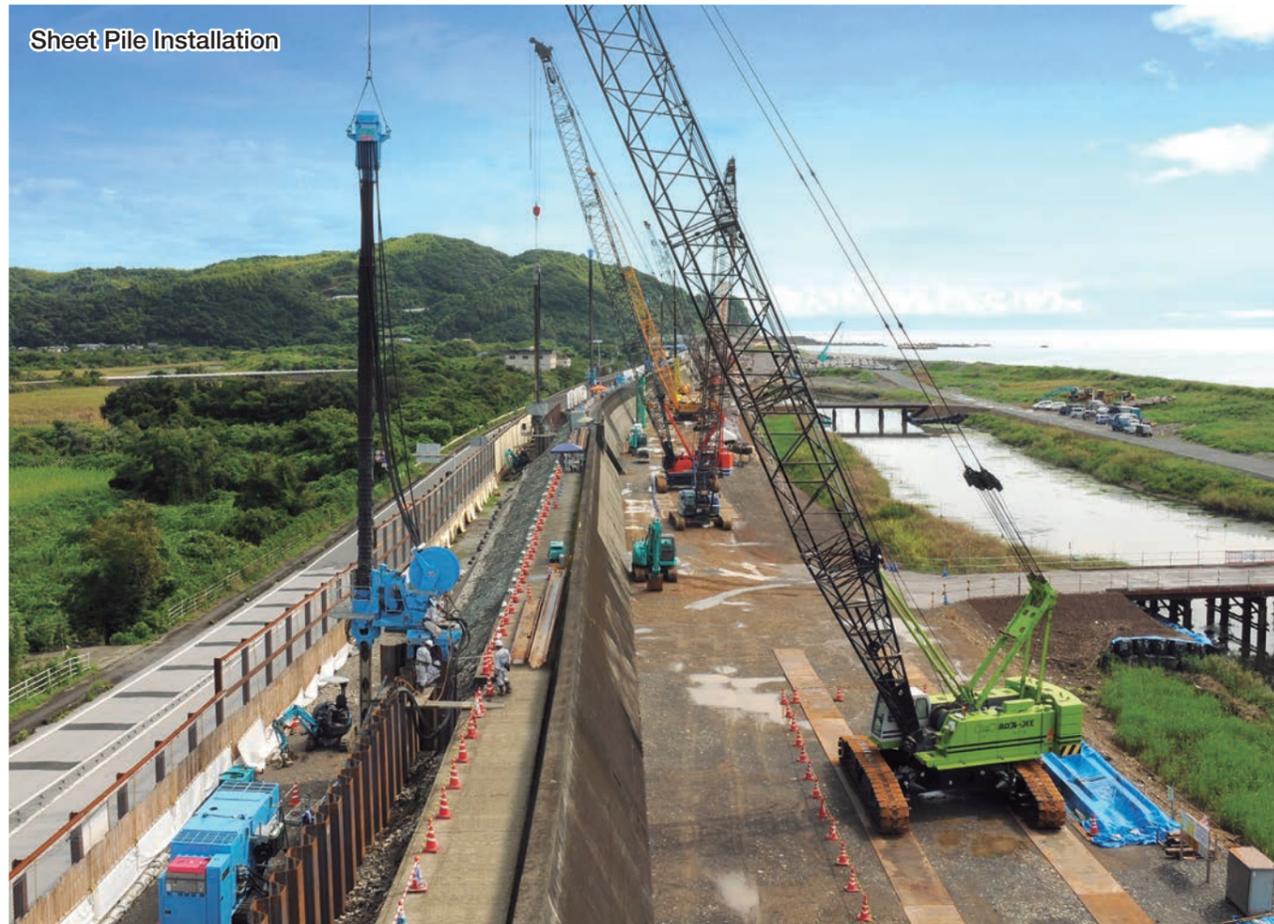
Sheet Pile Installation

## Twin Sheet Pile Walls installed with Press-in with Simultaneous Augering

2,399no. U Sheet Piles IVw L=15.0m - 16.5m (700Lm)

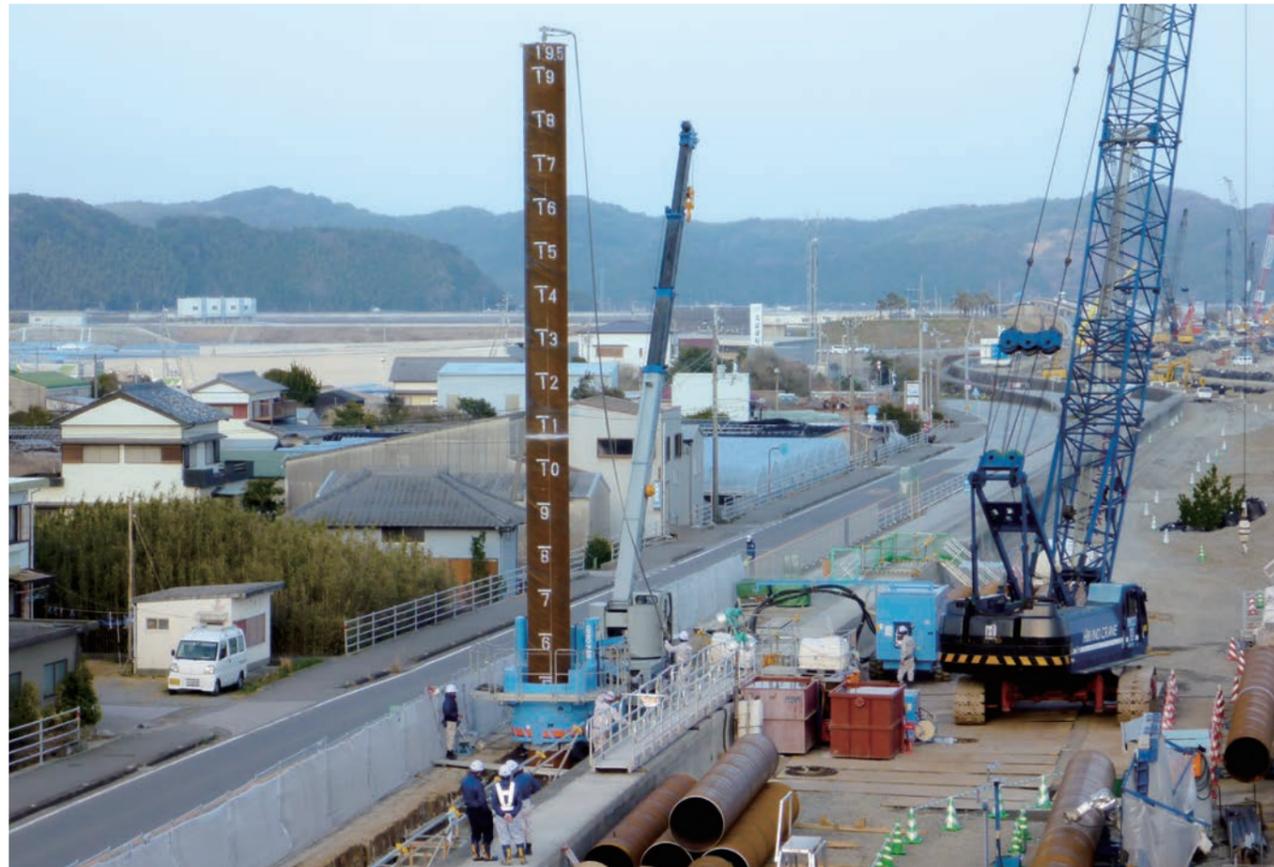
## Contiguous Tubular Pile Wall installed with Gyropress Method (Rotary Jack-in Method)

564no. Tubular Piles  $\phi 1,000\text{mm}$  L=19.5m (670Lm)

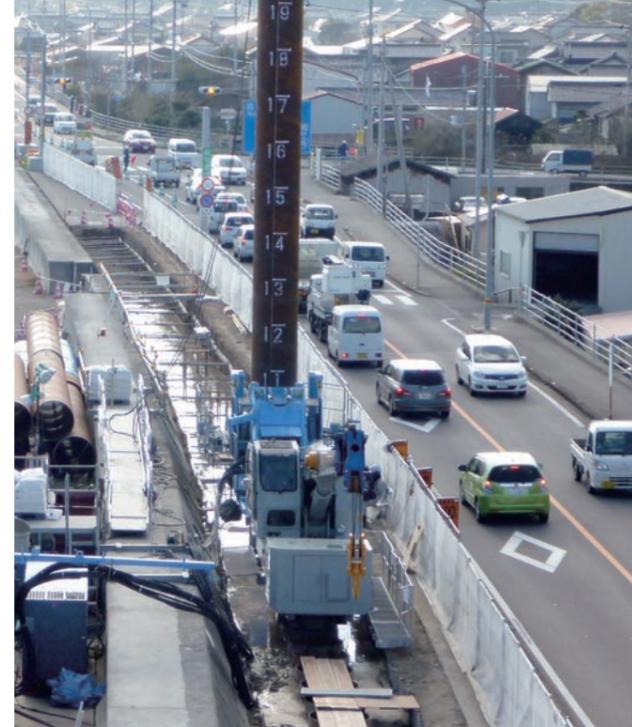
Pile Installation without disturbing adjacent traffic (Gyropress Method)

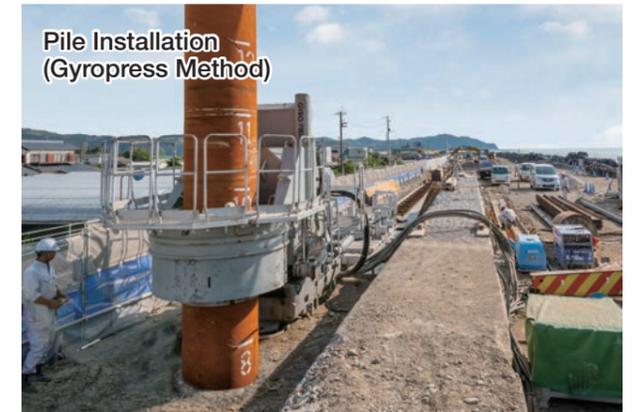
Pile Installation (Gyropress Method)

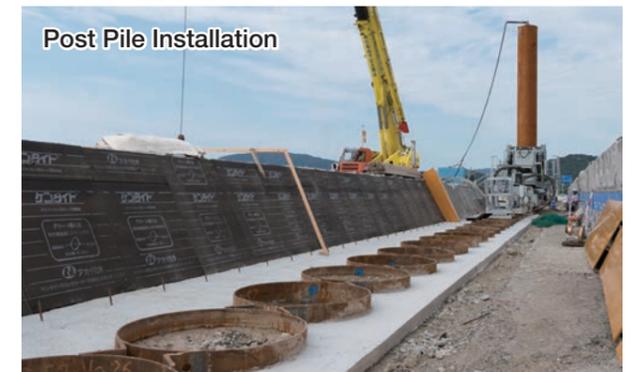
Post Pile Installation

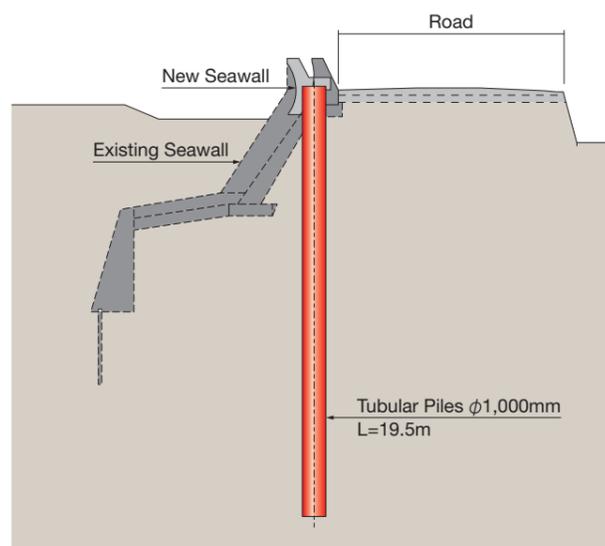
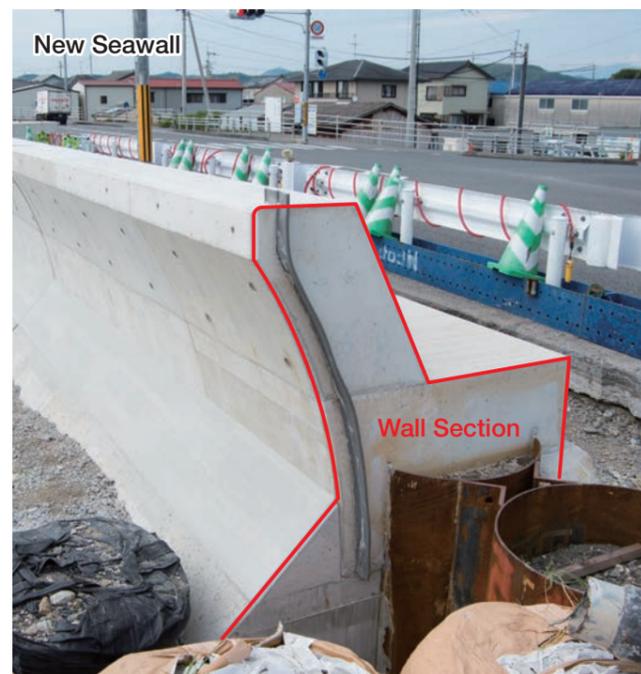
【Cross Section】

Sea Side

Land Side

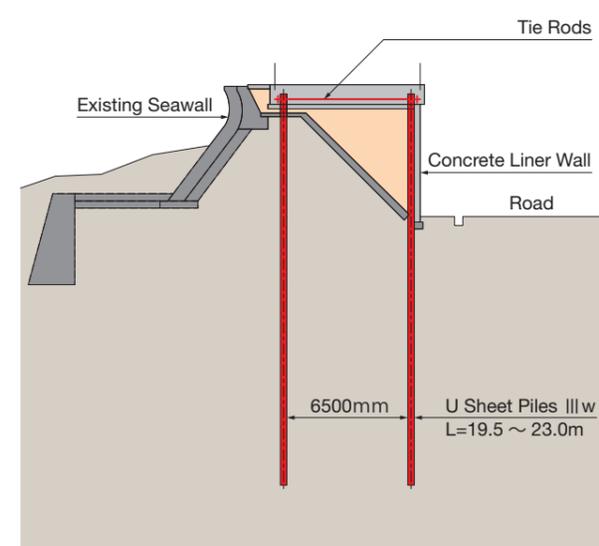
【Cross Section】

Sea Side

Land Side

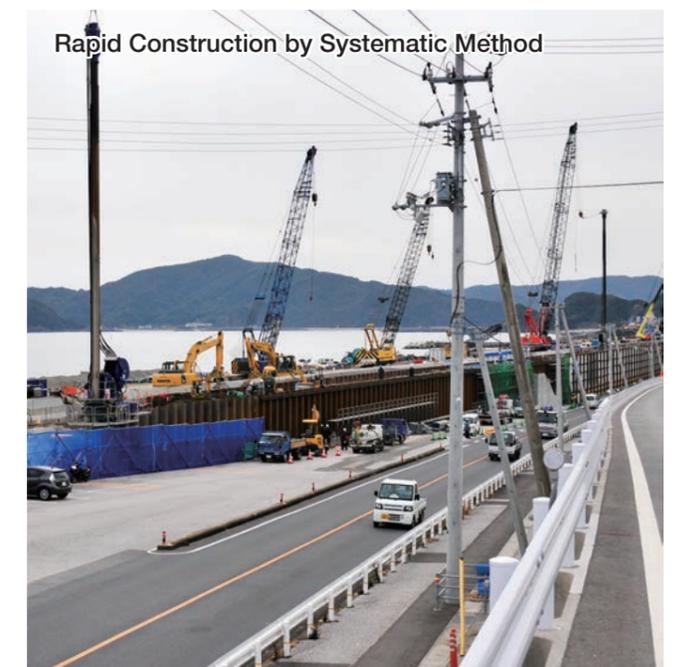
## Twin Sheet Pile Walls installed with Press-in with Simultaneous Augering

1,800no. U Sheet Piles III w L=19.5m - 23.0m (577Lm)

Rapid Construction by Systematic Method
